## Echocardiographic evaluation of heart valve prosthetic dysfunction

Yuriy Ivaniv

Department of Diagnostic Radiology, Danylo Halycky National Medical University, Lviv, Ukraine

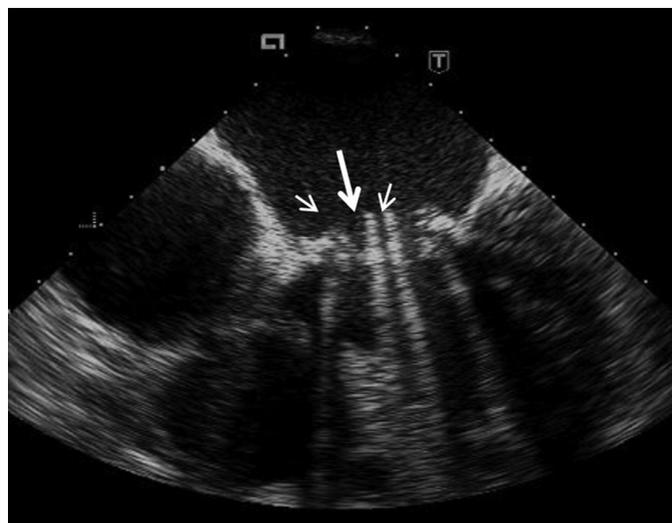
**Figure 1.** Transesophageal visualization of prosthetic bileaflet valve opening. Clearly seeing two disks in opened position as a parallel line with intensive shadowing down. It is also visible three parts of prosthetic orifice: the smallest one at the center between the two opened cusps (long arrow) and two bigger orifices laterally (short arrows)

There are three main types of mechanical valves, which differ primarily by the construction and functioning of occluders: tilting disk, bileaflet, and ball-and-cage. Monoleaflet tilting disk valves consist of a circular plain occluder which usually opens to the angle 60-80°. Bileaflet valves have occluders presenting by two semilunar disks attached to a rigid ring by tiny hinges (Figure 1). The opening angle of the discs relative to the ring plane achieves 75-90°, and the orifice of this valve has three parts: the smallest one at the center between the two opened cusps and two bigger semicircular orifices laterally. Caged-ball valves consist of a silastic ball with a circular metal ring and a cage formed by two or three metal arches (2).

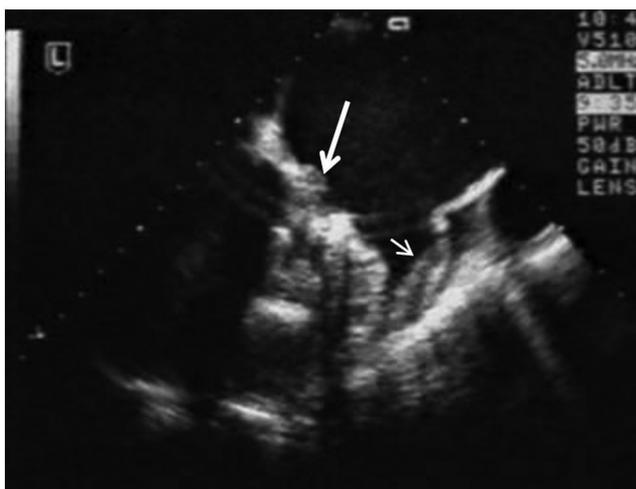
**Figure 2.** Transesophageal echocardiography of thrombus obstructing the orifice of mitral valve prosthesis (long arrow). At the same time the thrombus in left atrial appendix is visualized (short arrow)

- 1) Limited opening or completely blocked disc movement on the fluoroscopic examination,
- 2) Elevated Doppler gradients on the prosthetic valve on transthoracic echocardiography (TTE),
- 3) Detection of the thrombus during transesophageal echocardiography (TEE) (Figure 2).

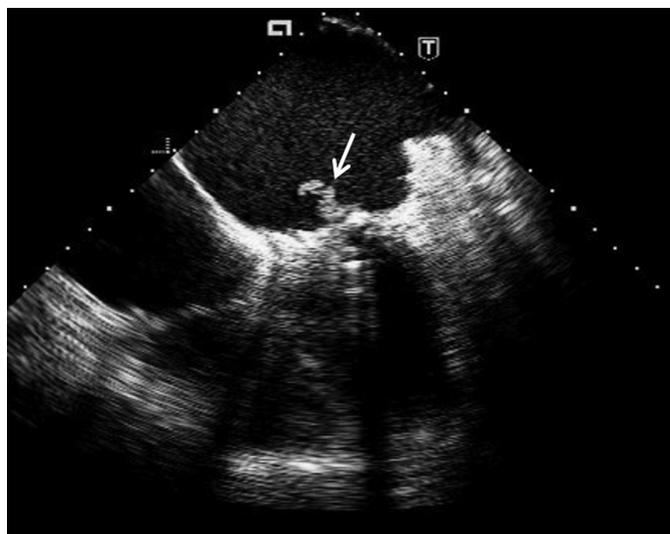
**Figure 3.** A long vegetation (arrow) attached to the atrial surface of mitral valve prosthesis visible by transesophageal echocardiography

Infective endocarditis could be a cause of prosthetic valve dysfunction (Figure 3). Its main echocardiographic manifestations include vegetation, thrombi on the replaced

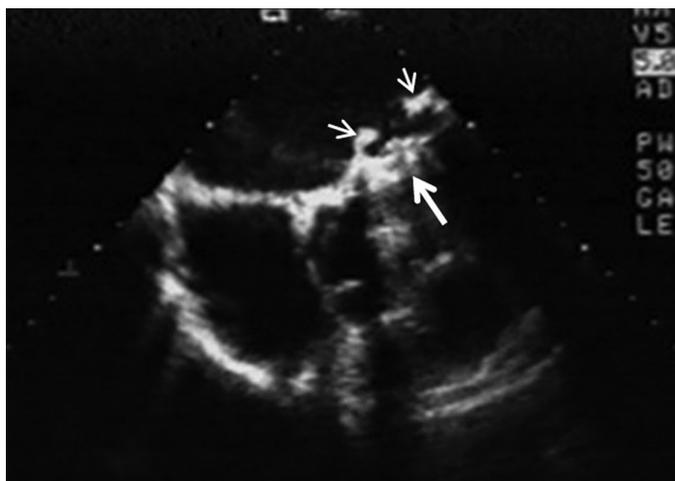
**Figure 4.** Pannus formation from the atrial side of mitral valve prosthesis (short arrows) visualized by transesophageal echocardiography. Partially opened prosthetic disk is limited in its movement by thrombus (long arrow)

One more cause of prosthetic valve dysfunction is pannus formation. Pannus is a connective tissue progressively growing into the orifice of the prosthesis and gradually obstructing it (1, 37). The pathophysiology seems to be explained by a chronic inflammation that results in the gradual and late clinical presentation looking like a thrombosis. But the correct diagnosis of pannus is critically important for choosing a treatment method since fibrinolytic agents could resolve thrombosis and have no effect on pannus (38). Cases of pannus are possible to diagnose mostly by TEE (Figure 4). According to the published data, the incidence of this complication is 1.6%–2% in the different series and occurs exclusively in mechanical prostheses more often in the aortic position (39, 40).
