Quiz: ECG - Pacemaker

The following 12-lead electrocardiogram (ECG) tracing is provided from a 72 years old male patient implanted with a dual-chamber pacemaker (Medtronic Astra DR), when applying a magnet. He underwent three previous persistent atrial fibrillation

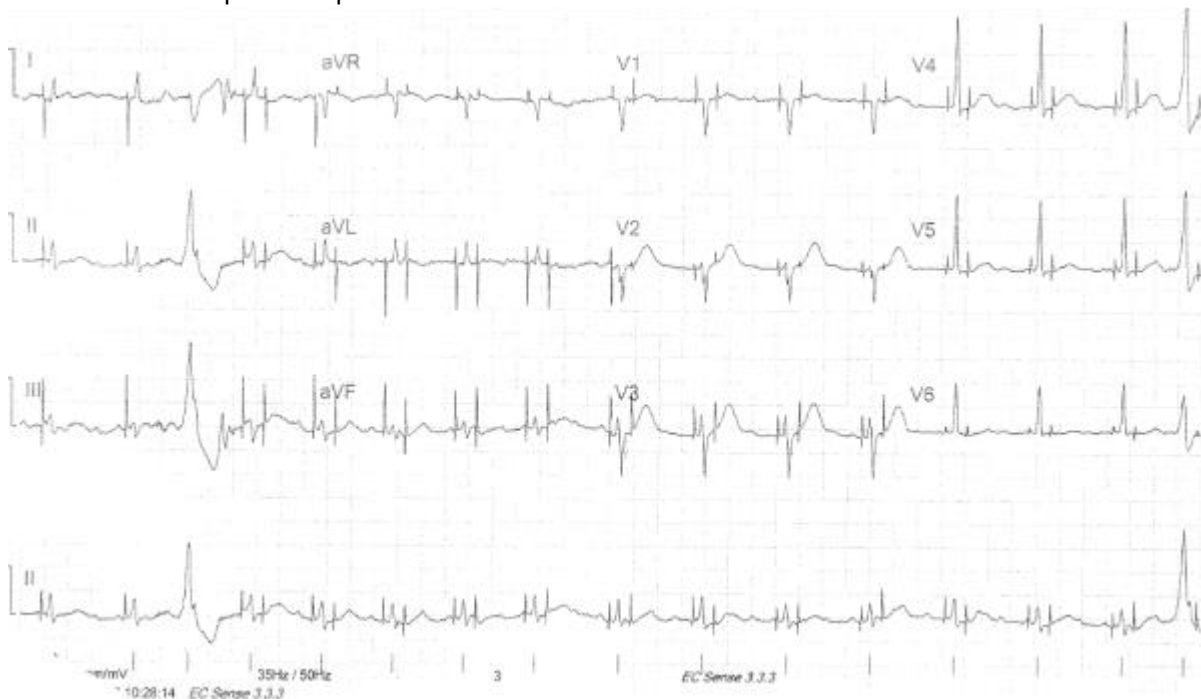
and atrial tachycardia radiofrequency ablations, and an additional atrioventricular node ablation procedure (left ventricular ejection fraction 45%). The patient does not report any cardiovascular symptom.

Figure 1. A 12-lead electrocardiogram recording

1. The pacing leads have been connected to the incorrect port of the pacemaker.
2. There is a ventricular lead dysfunction because the second spike is not followed by any paced ventricular complex.
3. Fusion between native QRS and paced QRS is present as QRS complexes are narrow.
4. This tracing demonstrates normal magnet response to this pacing system.

5. The patient is in sinus rhythm
